UTICA PUBLIC LIBRARY

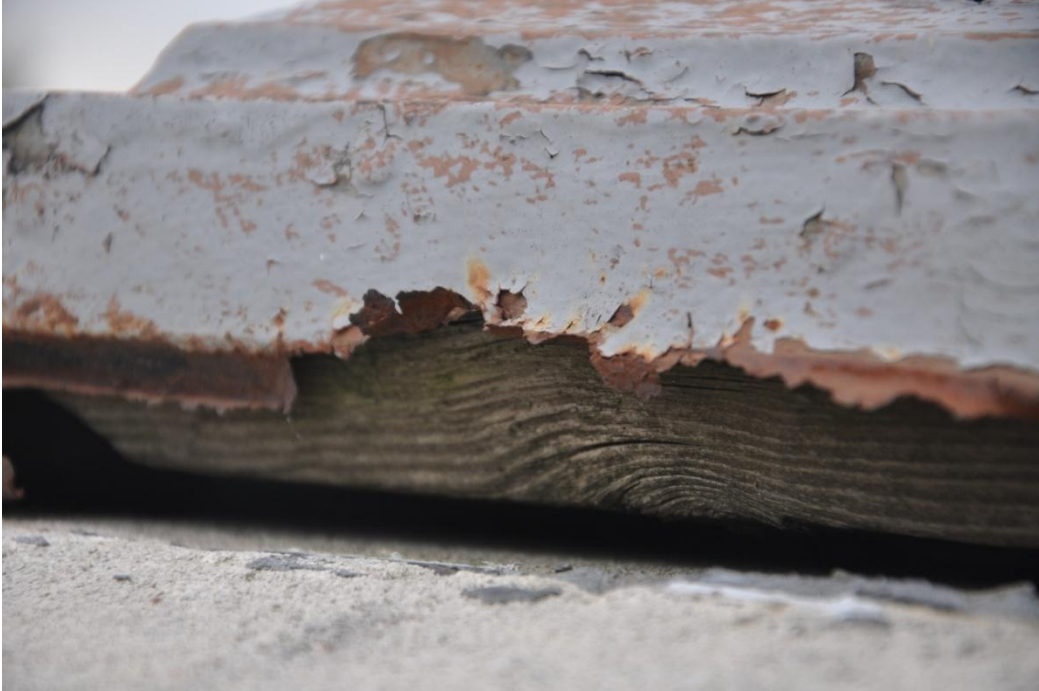
1. Gutter trim has deteriorated beyond repair. Metal has rusted away and is exposing the underlying wood blocking and opening for water penetration.

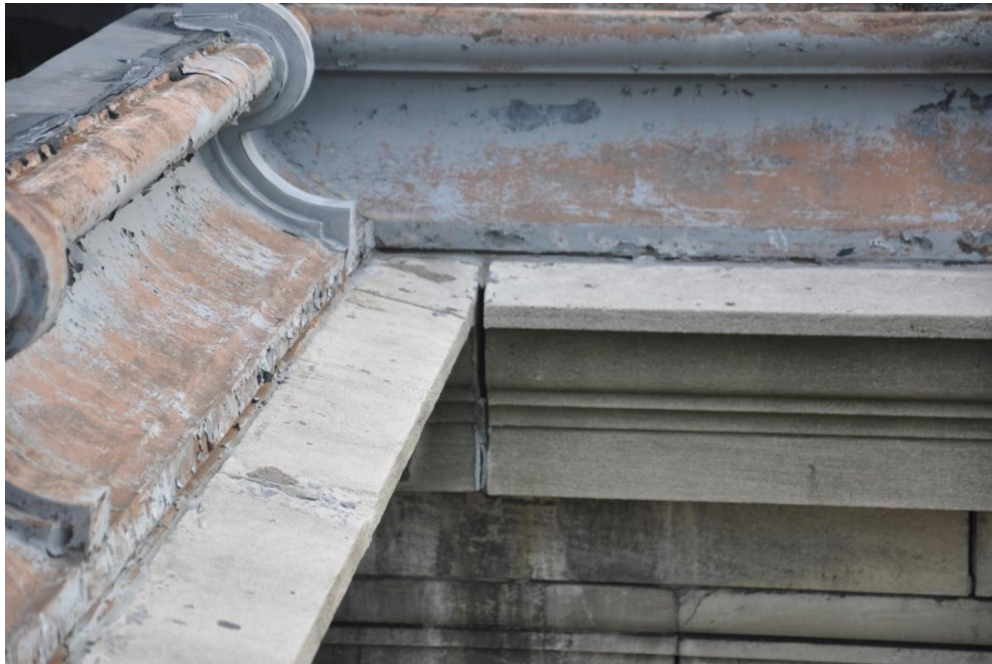
2. Open joints in stone cornice are points of entry for water. Joints should be cleaned and made water tight.

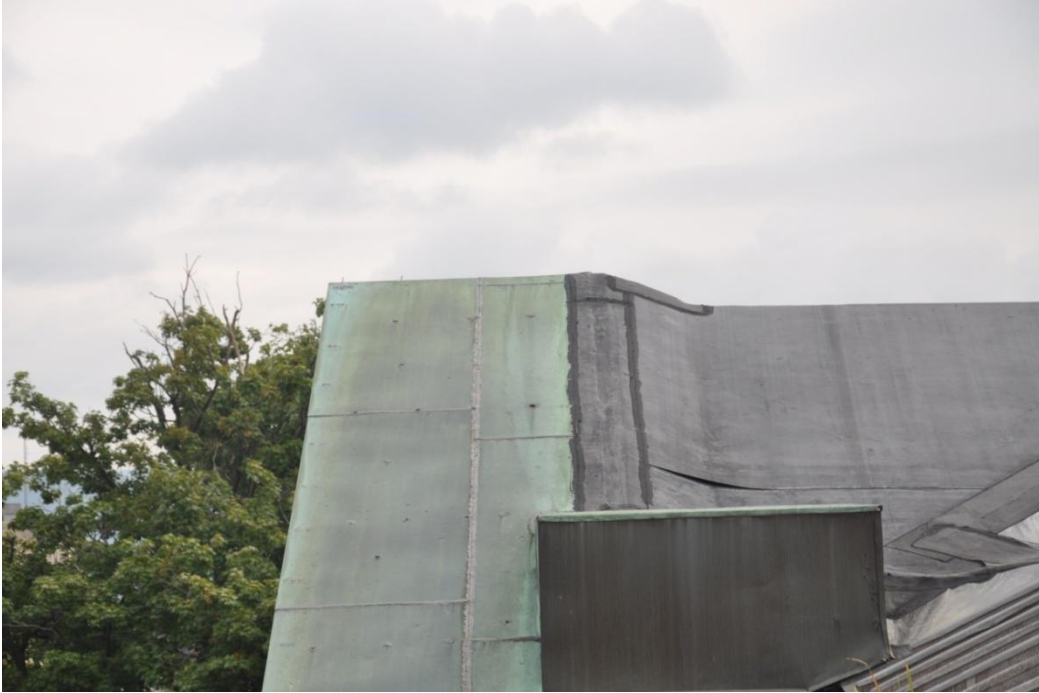
3. Seams of single ply rubber roof are beginning to open. Sealant on patched areas are deteriorating.

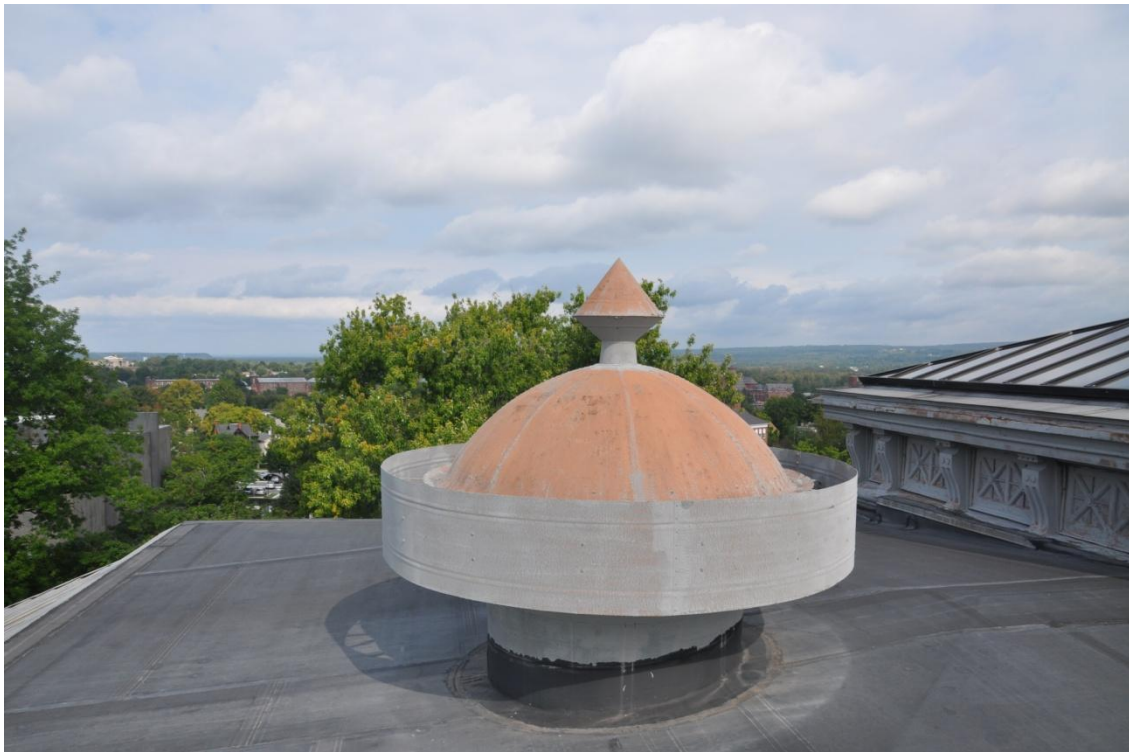
4. View of single ply roofing. Seams and flashing at base of skylight are deteriorating. Single ply roofing was installed in 1990. Roofing system had a ten year warranty.
